**DEPARTMENT OF TRANSPORTATION**

Contract #: 04-0120F4Cty: SF/ALA Rte: 80 PM: 13.2/13.9File #: 69.28**WELDING INSPECTION REPORT****Resident Engineer:**Pursell, Gary**Address:** 333 Burma Road**City:** Oakland, CA 94607**Report No:** WIR-014523**Date Inspected:** 01-Jun-2010**Project Name:** SAS Superstructure**OSM Arrival Time:** 700**Prime Contractor:** American Bridge/Fluor Enterprises, a JV**OSM Departure Time:** 1900**Contractor:** Zhenhua Port Machinery Company, Ltd (ZPMC), Changxing Island **Location:** Shanghai, China**CWI Name:** Mr.Liu Hua Jie**CWI Present:** Yes No**Inspected CWI report:** Yes No N/A**Rod Oven in Use:** Yes No N/A**Electrode to specification:** Yes No N/A**Weld Procedures Followed:** Yes No N/A**Qualified Welders:** Yes No N/A**Verified Joint Fit-up:** Yes No N/A**Approved Drawings:** Yes No N/A**Approved WPS:** Yes No N/A**Delayed / Cancelled:** Yes No N/A**Bridge No:** 34-0006**Component:** Orthotropic Box Girder( OBG)**Summary of Items Observed:**

OBG TRIAL ASSEMBLY.

Lift 8 West.

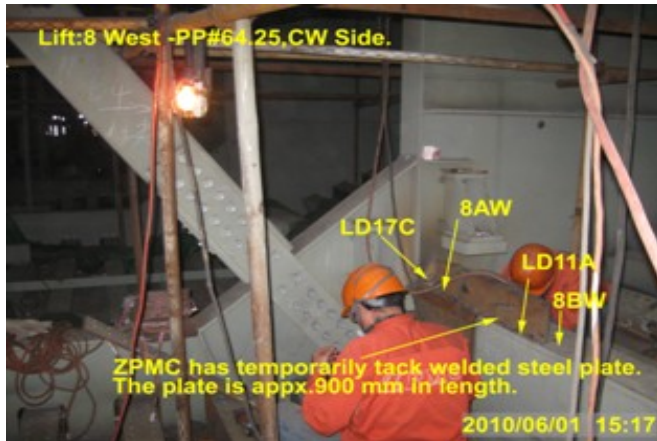
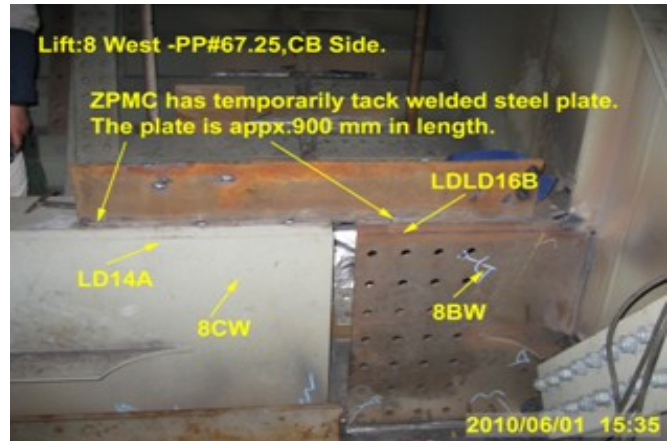
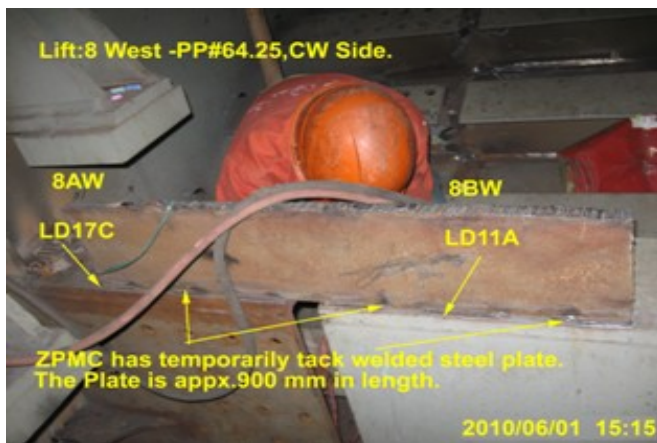
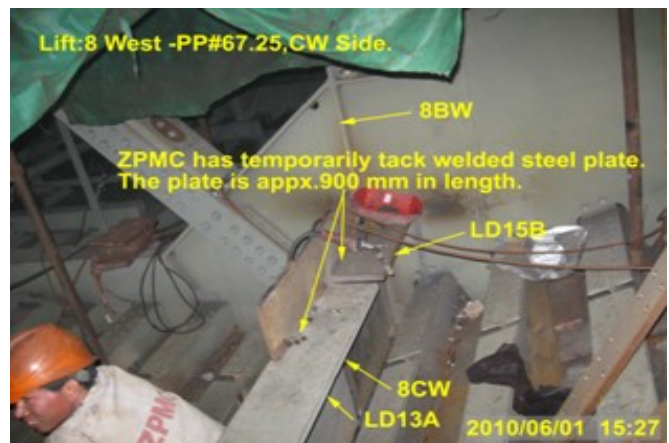
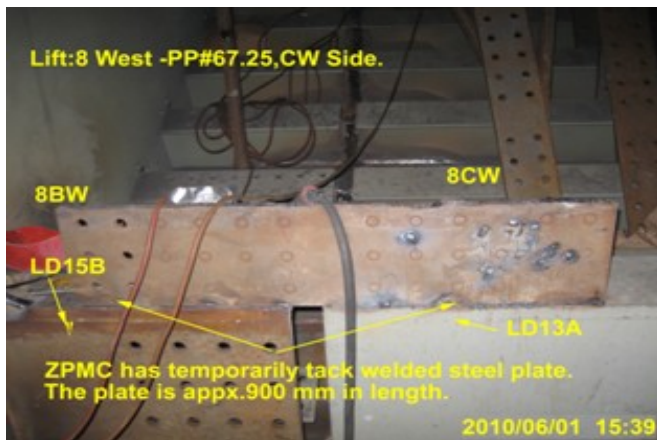
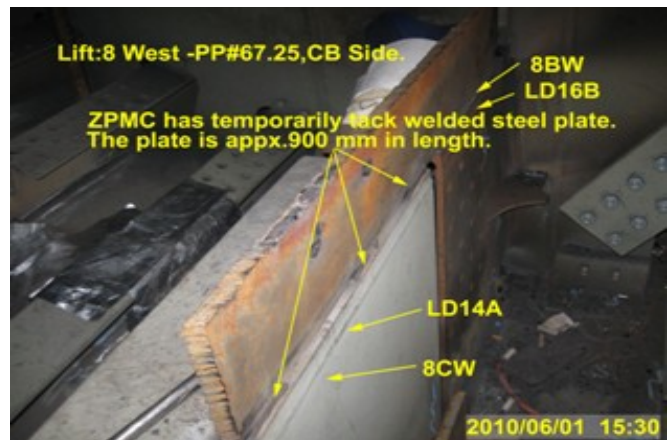
During the Quality Assurance (QA) random visual inspection of Orthotropic Box Girder (OBG) Longitudinal Diaphragm (LD) at Lift 8 West, this QA Inspector observed ZPMC has temporarily tack welded steel plates on top of the LD's at 3 locations. The approved shop drawings do not specify any welds in these locations. The LD's are identified as: LD17C and LD11A, LD15B and LD13A, LD16B and LD14A. The material composition of the added steel plate being welded to the LD's is not known.

This QA Inspector generated an incident report on this date, for further information see the incident report and attached pictures.
